Mafube Coal Mining (Pty) Ltd

Environmental Audit Report

MAFUBE COLLIERY

SPRINGBOKLAAGTE MINING OPERATION

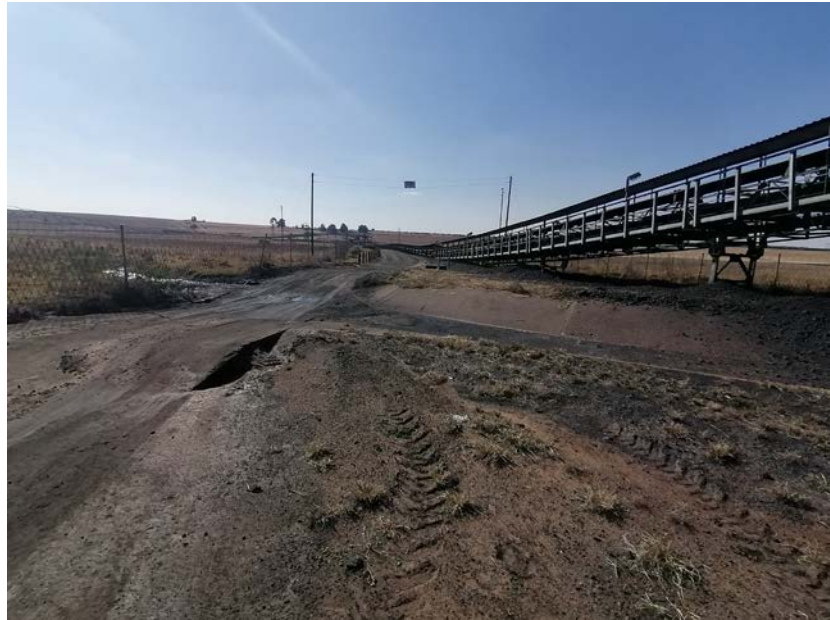
Condition number	Condition	Finding	Observation/ Audit Evidence
	accumulation of water and soil erosion.		<p>separation of clean and dirty water. Site visit has around the conveyor and rail loops has confirmed that no accumulation of water and soil erosion occurs. Dirty water from the conveyor belt is directed to Overland 1 dam and Overland dam 2. It was however not confirmed where dirty storm water from the rail loop was directed. Based on site observation, it seems dirty storm water from the rail loop is directed to nearby veld (clean water environment). See picture below.</p> <p>It is hence recommended that an investigation be conducted to determine whether or not the rail loop storm water management is in line with the GN 704 requirements.</p> <p>Picture showing assumed dirty storm water reporting to the clean water environment.</p>

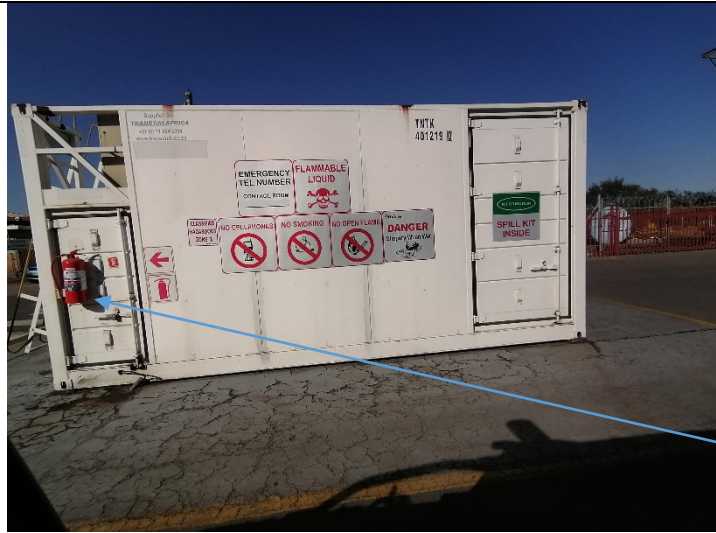
28.	Appropriate measures must be implemented to prevent and control veldfires.	Compliant	Fire extinguishers are available and around the fuel storage area and a firebreak plan has been implemented at Mafube Colliery.

<p>Fire extinguishers available at the storage tanks</p>
29.	Stringent measures must be applied to suppress dust emanating from the construction site.	Not Applicable	The Above Ground Storage Tanks is under operational phase and no construction activities are undertaken. Therefore, this condition is not applicable.

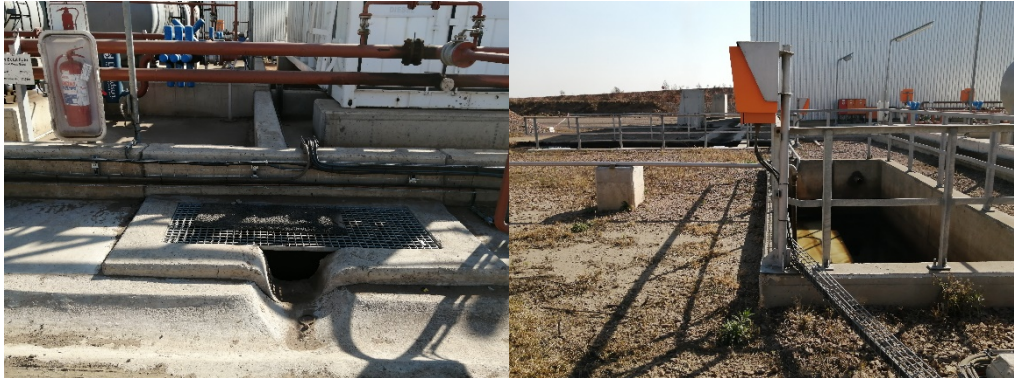
1.19.	A three-level containment system must be installed with the tank to ensure that spills and leaks are managed and possibly eliminated. If the spill occurs in a secondary	Compliant	A three-level containment system is installed for managing of spills and leaks. The tanks are fitted with a sump and a hydrocarbon separator.

<p>Sump and a hydrocarbon separator</p>

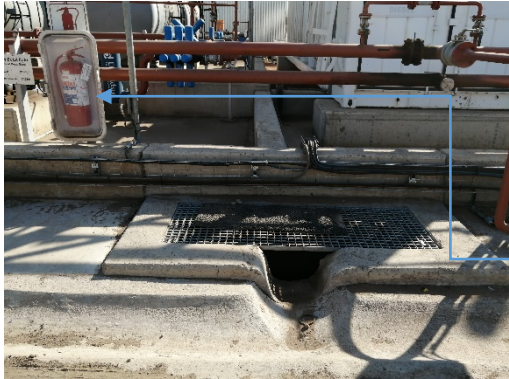
1.24.	Appropriate measures must be implemented to prevent and control veldfires.	Compliant	<p>Fire extinguishers are available around the fuel storage area and a firebreak plan has been implemented at Mafube Colliery.</p>

<p>Fire extinguishers available at the storage tanks</p>

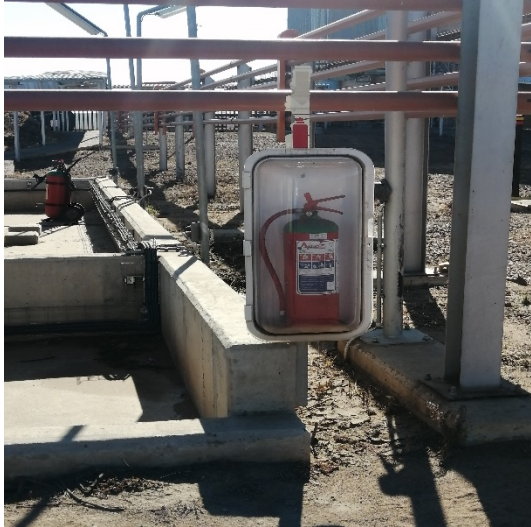
CONDITION NO	CONDITION	FINDINGS	OBSERVATIONS/AUDIT EVIDENCE
	against fire.		
3.40.	Fire extinguishers must be installed in areas that are easily accessible in the event of fire.	Compliant	<p>Site observations confirmed that fire extinguishers are available on site and near the above ground storage tanks area.</p>

<p>Fire Extinguisher located on site</p>

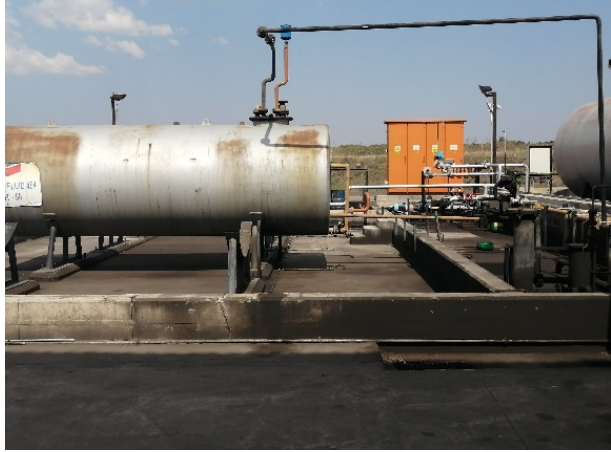
COMMITMENT NO.	MITIGATION MEASURES	FINDINGS	OBSERVATION/ AUDIT EVIDENCE
	The site is located in an open space, where there are no structures that can impede access to the drain plug or filling point of the tank via the ladder.	Noted	The condition is well understood by Mafube Colliery Management.
	The sites are chosen so that they are not located close to flammable materials (sheds, eucalyptus plantations etc).	Noted	The condition is well understood by Mafube Colliery Management.
	The site location allows safe access for Shell's bulk delivery vehicle, taking into consideration the turning circle requirement of these vehicles.	Noted	The condition is well understood by Mafube Colliery Management.
	All above-ground tanks are sited on a bunded area in accordance with SABS 089 requirements.	Compliant	<p>The above-ground tanks are placed on a bunded area.</p>

<p>Bunded area of the above-ground tank</p>

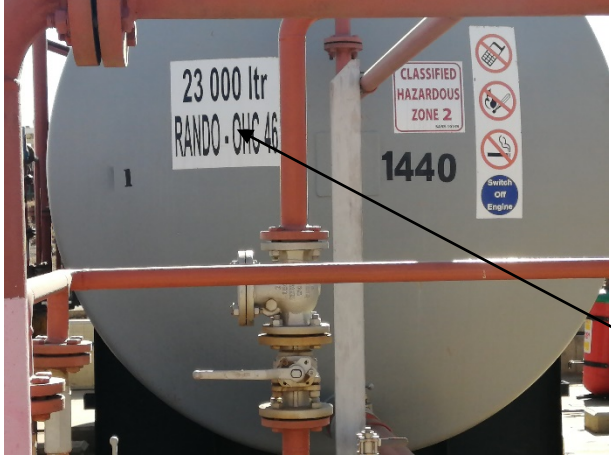
<p>Volumes of the above ground tanks</p>
	No smoking signs must be posted in visible locations around the storage facilities.	Compliant

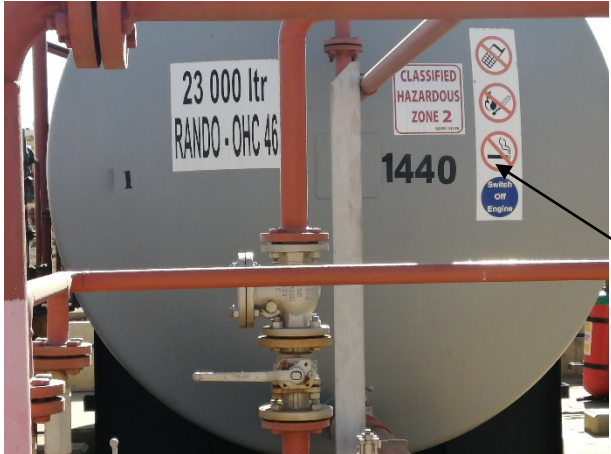
<p>No smoking signs erected on the above ground tanks</p>
	Firefighting equipment must be available in the vicinity of the fuel storage facility.	Compliant	Firefighting equipment utilised at the workshop area which is located next to the diesel tank facility are used for any emergency arising from the diesel tank facility.
	Emergency contact numbers must be posted in the same location.	Compliant	Emergency contact numbers are posted at the workshop area in close proximity to the diesel tank facility.
ACCESS ROUTE

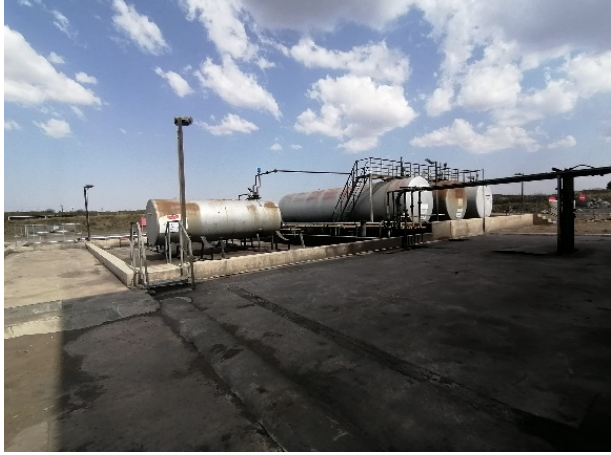
COMMITMENT NO.	MITIGATION MEASURES	FINDINGS	OBSERVATION/ AUDIT EVIDENCE
	Sufficient space will be provided to allow the delivery vehicle to turn around, in accordance with the turning scenarios and space requirements which will be specified by Shell.	Compliant	<p>Sufficient space is provided to allow the delivery vehicle to turn around from the above ground tanks area.</p>

<p>Sufficient space for delivery vehicle to turn around from the above ground tanks area</p>
	At no point must the delivery vehicle leave the road or drive across areas of natural vegetation.	Compliant	It was confirmed during the site visit that no delivery vehicles leave the road or drive across areas of natural vegetation. The delivery vehicles travel along designated routes.
TANK MAINTENANCE			
	In addition, the responsible site managers will ensure that the tanks are inspected regularly.	Compliant	The above ground tanks are inspected by Mafube Colliery Environmental Department on weekly basis.

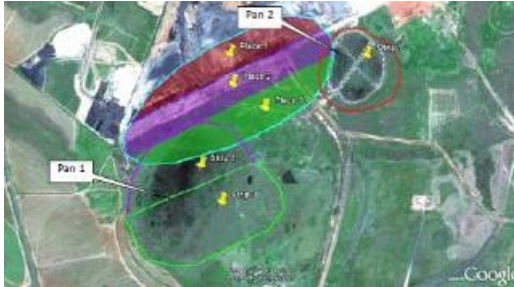
8.3.2.2	<p>Proposed excavation sequence:</p> <p>Terrasol Science (2011) indicated that the stripping of pan soils must be aligned with the placement of the clay soils on the pan construction site. It is critical that these soils are placed in the wet state and that the soils are prepared as a lining immediately after placement.</p> <p>The figure (as extracted from the BAR, July 2013) below, provides an indication of the excavation and placement sequence at the pan site as proposed by Terrasol Science (2011). As indicated in the figure below, the clays from Pan 2 (Strip 1) should first be stripped and immediately placed on the northern edge of the intended pan (Place 1). Strip 2 (northern part of Pan 1) would then be excavated and immediately placed at Place 2 followed by Strip 3 (southern part of Pan 1) and the placement thereof at Place 3.</p>

<p>Proposed excavation and placement sequence</p>	Compliant	Stockpiling of soils was done separately as was removed.

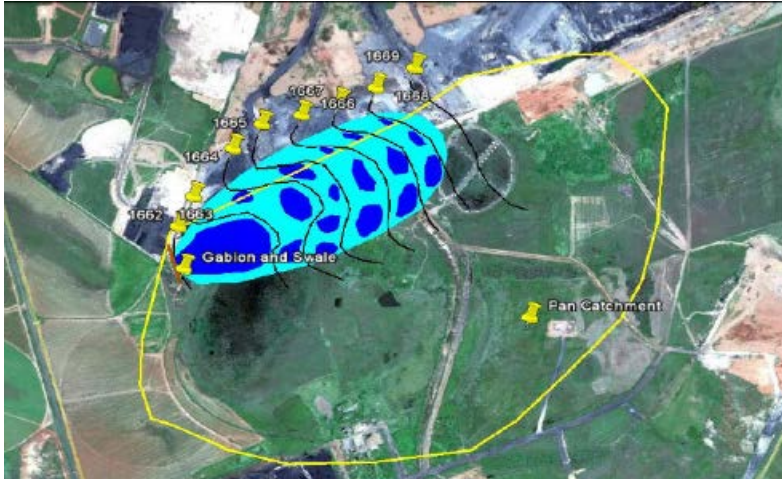
8.4.1 & 8.4.3	<p>Section 4.10.3 of Appendix 4 (Terrasoil report) provides an overview of pan design criteria and types investigated by Terrasoil Science (2011).</p> <p>The goal will be to create a pan that has a partially freshwater component and a partially brackish water component that will operate at some level of functionality.</p>

<p>Schematic layout of the proposed pan design</p>	Not Applicable	This condition is not applicable, the pan recreation activities (topsoil replacement and revegetation have not yet commenced, but rather only the backfilling of the mined-out areas.

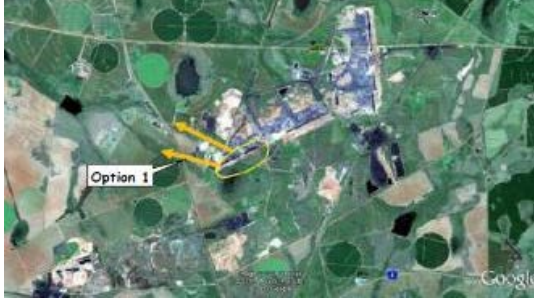
8.4.4	Terrasoil Science (2011) indicated that the overflow area of the pan could be situated in one of two positions (as indicated in the figure below). These positions correspond to the upper	Compliant	The Preliminary designs report for the Pan-re-establishment project (Jones and Wagener) (Report No JW133/15/F047 – Rev 0)", dated August 2015,

Condition number	Condition	Finding	Observation/ Audit Evidence
	<p>reaches of a stream that flows towards the west.</p> <p>Option 1 is the preferred option since it appears not to have any associated mining activities.</p>

<p>Position of pan overflow options</p> <p>The lowest point in the post rehabilitation landscape will have to be identified as well as the distance from this point to the nearest watercourse or drainage channel. Once this has been determined, a constructed drainage channel (for continuity (linkage) and decanting purposes) must be designed as part of the overall pan design. In addition, flow reduction and erosion control measures will have to form part of the said design.</p>		<p>has reference. This report included hard copies of the following design drawings.</p> <ul style="list-style-type: none"> • F047-01-001: Test pit positions • F047-01-002: Typical liner cross sections • F047-02-001: General arrangement • F047-02-002: Canal 1 – Plan and Longitudinal Section • F047-02-003: Canal 2 – Plan and Longitudinal Section • F047-02-004: Canal 3 – Plan and Longitudinal Section • F047-02-005: Canal 1, 2 and 3 – Typical Cross Sections • F047-02-006: Wetland C – Berm and Typical Section • F047-02-007: Canal Inlet and Outlet Typical Section • F047-02-008: Canal 3 – Typical Outfall Details • F047-02-009: Canal – Typical Step detail • F047-02-010: Canal 1 – Typical storm water Inlet Details • F047-02-011: Wetland C overflow – Plan and Sections
